## **DEVELOPMENT OF INTERNAL (TRENCHLESS) REPAIR TECHNOLOGY FOR GAS TRANSMISSION PIPELINES\***

W. A. Bruce, D. D. Harwig,  
I. D. Harris and J. R. Gordon  
**Edison Welding Institute**  
Columbus, Ohio

M. Sullivan and  
C. Neary  
**Pacific Gas & Electric**  
San Ramon, California

\* For presentation at Natural Gas Technologies II, GTI Conference & Exhibition, February 8-11, 2004, Phoenix, Arizona.

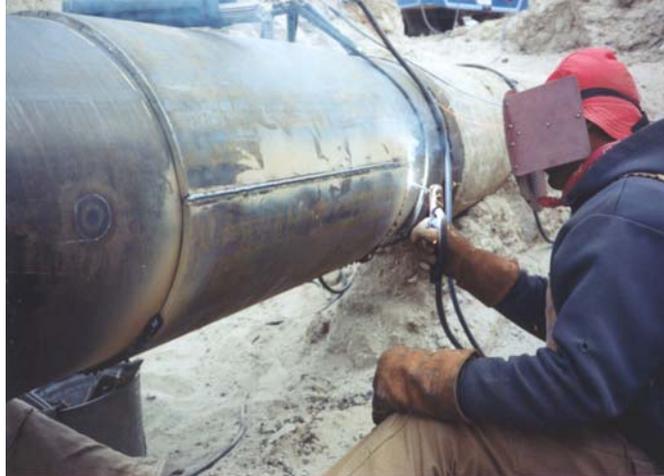
**Figure 1 - Installation of a Welded Full-Encirclement Steel Repair Sleeve**

The most common cause for repair of gas transmission pipelines is external, corrosion-caused loss of wall thickness. To prevent an area of corrosion damage from causing a pipeline to rupture, the area containing the corrosion damage must be reinforced. Other pipeline defects that commonly require repair include internal corrosion, original construction flaws, service-induced cracking, and mechanical damage. Defects oriented in the longitudinal direction that have a tendency to fail from hoop stress (due to pressure loading) must be reinforced in the circumferential direction, while defects oriented in the circumferential direction that have a tendency to fail from axial stresses (e.g., pipeline settlement) must be reinforced in the longitudinal direction. The most commonly used method for repair of gas transmission pipelines is the installation of welded full-encirclement steel repair sleeves (Figure 1). These sleeves resist hoop stress and, if the ends are welded to the pipeline, can resist axial stresses.

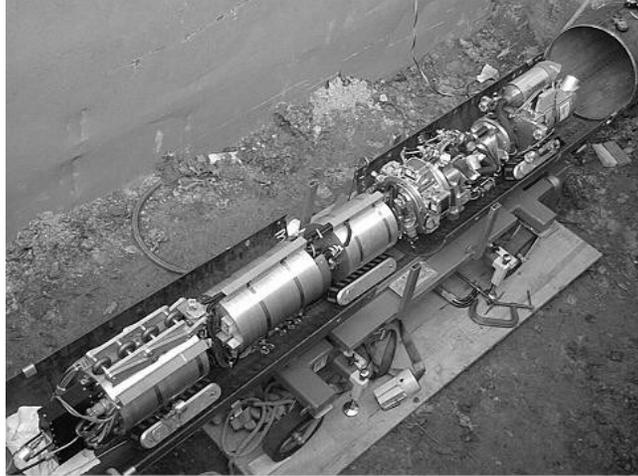
Pacific Gas and Electric Company (PG&E) has developed the Internal Pipeline NDE System (IPNS) for internal inspection of gas pipelines (Figure 2). This system incorporates a variety of inspection technologies to characterize girth and long seam flaws, corrosion, and dents and gouges. A grinder is incorporated for preparation of areas of interest. The system has been in field use since 1996 and has a maximum range of 2,500 ft. The robot is self-propelled using tracks and is able to traverse 90-degree bends in 22- to 24-in.-diameter pipe. An umbilical is used to supply power and to control the device. Preliminary development work was performed for a companion system to perform machining and welding of defective welds. While not a welding system, IPNS demonstrates the practicality of performing work inside gas pipelines at extended distances from the entry point.

**Figure 2 – Pacific Gas & Electric Internal Pipeline NDE System**

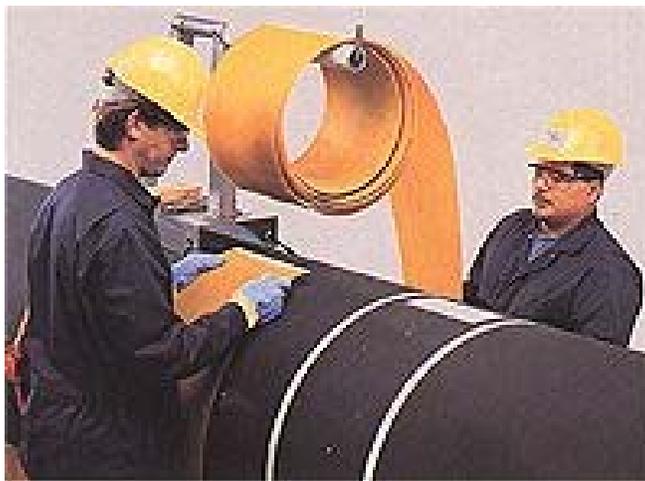
Fiber-reinforced composite repairs are becoming widely used as an alternative to the installation of welded full-encirclement steel sleeves for repair of gas transmission pipelines. These repairs typically consist of glass fibers in a polymer matrix material bonded to the pipe using an adhesive (Figure 3). Adhesive filler is applied to the defect prior to installation to allow load transfer to the composite material. The primary advantage of these repair products over welded full-encirclement steel repair sleeves is that the need for welding is precluded.

**Figure 3 - Installation of a Fiber-Reinforced Composite Repair Device**

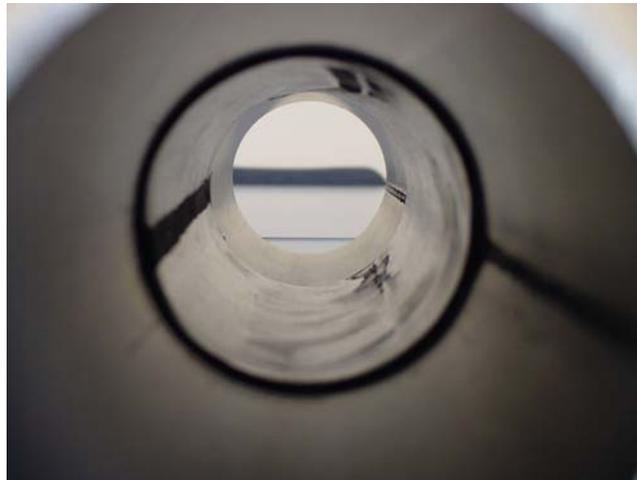
A supply of 4.5-in.-diameter  $\times$  0.156-in. wall thickness API 5L Grade B pipe material was procured and cut into four sections approximately 4-ft long. After the inside surface was degreased, lengths of lining were installed into two of the pipe sections. The installation process consisted of inserting a silicon rubber bag inside the liner and locating the liner inside the pipe. The silicon bag was then inflated to press the liner against the pipe wall. For these experiments, the entire pipe sections were then heated in an oven to approximately 400°F to fuse the liner to the pipe wall. Possible choices for liner installation in the field include infrared (IR) heaters on an expansion pig or a silicon bag inflated using hot air. An installed liner is shown in Figure 6.

**Figure 6 - Liner Inserted into Center of 4.5-in.-Diameter Pipe**

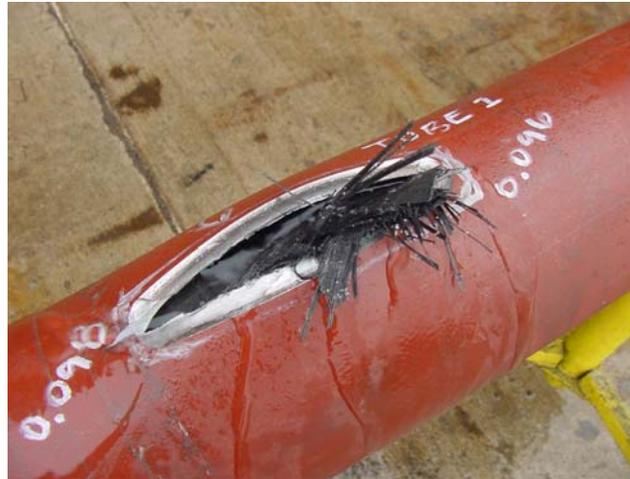
All four pipe sections failed in the areas of simulated corrosion damage. Both pipes with long shallow damage representative of general corrosion resulted in ruptures (Figure 7). The two pipes with short, deep damage representative of a deep isolated corrosion pit developed leaks. The failure pressures for the pipes with the liners were only marginally greater than the pipes without liners (i.e., 3472 vs. 3431 psi for the pipe samples containing long shallow damage and 4031 vs. 3750 psi for the pipe samples containing short, deep damage). This indicates that the liners were generally ineffective at restoring the pressure-containing capabilities of the pipes.

**Figure 7 - Pipe Section with Liner Following Hydrostatic Pressure Test**

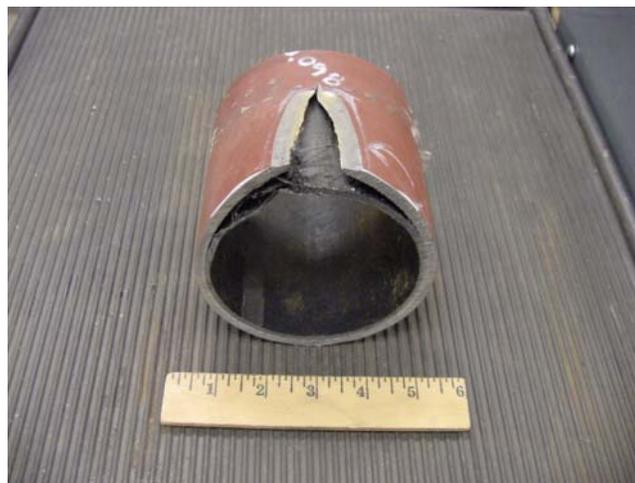
A postmortem analysis was conducted on the four hydrostatic burst tests in pipe sections with simulated corrosion. To avoid damage to the liner, water jet cutting was used to section the pipe sample containing the round-bottom longitudinal slot with the liner installed (Figure 8). The results indicated that the liner did rupture, and that disbonding was not an issue.

**Figure 8 - Water-Jet Cut Section through Pipe Section with Liner**

Further analysis indicated that the difference in modulus of elasticity between the steel and liner materials prevents the liner from carrying its share of the load. The modulus of elasticity for steel is approximately  $30 \times 10^6$  psi. Tensile testing was carried out to determine the modulus of elasticity for the glass/polypropylene liner material that was used. The mean value for the modulus of elasticity for the liner material was measured to be approximately  $2.2 \times 10^6$  psi. Because the liner material had a significantly lower modulus of elasticity than the steel pipe, as pressure in the lined pipe increases, the stiffness of the steel prevented the composite liner material from experiencing enough strain to share any significant portion of the load. Therefore, the mechanical properties of this liner material were inadequate for internal pipe repair.

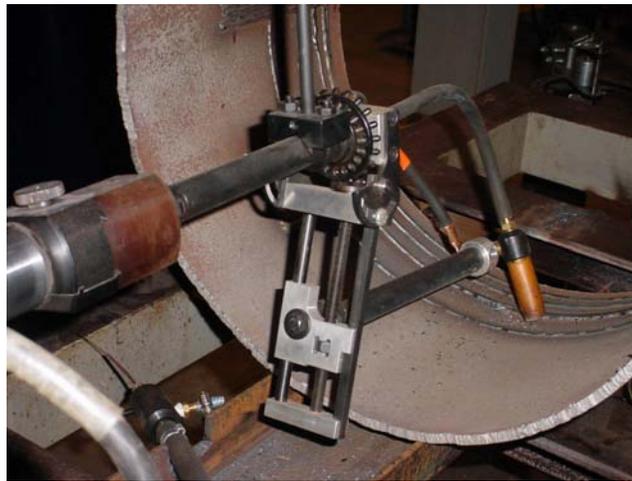
The Bortech system was selected initially because it is affordable, uses simple motors for motion, and has simple controls for operating constant voltage (CV) power supplies (Figure 9). It was necessary to purchase and install a counterbalance to offset the weight of the opposing torch.

**Figure 9 - Bortech Internal Bore Cladding System**

Preliminary weld trials with the Bortech system using an 0.035-in.-diameter ER70S-6 filler metal (i.e., electrode) produced marginal results. Only stringer beads could be deposited using short-circuit transfer in the spiral-clad mode. With stringer beads, the deposition rate was low since only narrow beads could be deposited. The bead shape suffered the most in the overhead position when starting downhill. The Bortech system does not allow torch weaving, which is required to improve weld bead profile thus allowing higher deposition rates and improved fusion. In principle, the Bortech system could be made suitable for an internal repair system. Anti-backlash servo-motors and gears, and programmable controls would be required, as well as an additional motor drive to permit control of the torch and work angle.

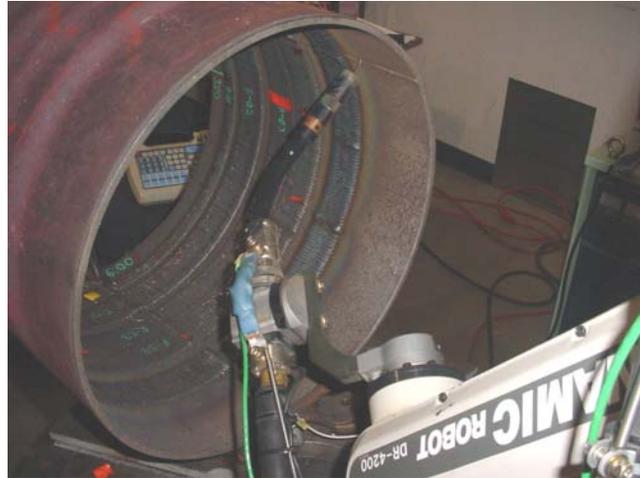
Based on the results experienced with the Bortech system, it was decided to develop preliminary welding procedures using a robotic GMAW system. The use of a six-axis coordinated motion OTC robotic welding system (Figure 10) permitted the application of weave beads for spiral cladding, or for stringer beads, in either direction. The system did not have a commutator for welding torch current that would permit continuous spiral welding. The robot was interfaced to an advanced short-circuit power supply, the Kobelco PC-350, which uses fuzzy-logic pulse waveforms to minimize spatter during metal transfer and permits the application of variable polarity waveforms. Variable polarity combines the rapid, low heat input melting of a negatively charged electrode with the metal transfer stability of electrode positive.

**Figure 10 - OTC Robotic Welding System**

The OTC robot welding system was used to develop preliminary repair welding procedures with the intent that they would be transferred to a different system for pipeline repair demonstrations. A range of orbital weave parameters were developed to establish an operating window, and to determine deposit quality and deposition rate. The ideal weld bead shape would have uniform thickness across the weld section except near the weld toes which should taper smoothly into the base material. Smooth toes promote good tie-ins with subsequent weld beads. The fusion boundary should be uniform and free from defects. Preliminary tests were also performed to evaluate bead overlap and tie-in parameters that would be required to make high quality repairs. All the welding tests were performed with a 95% argon-5% carbon dioxide shielding gas mixture using an 0.035-in.-diameter ER70S-6 electrode.

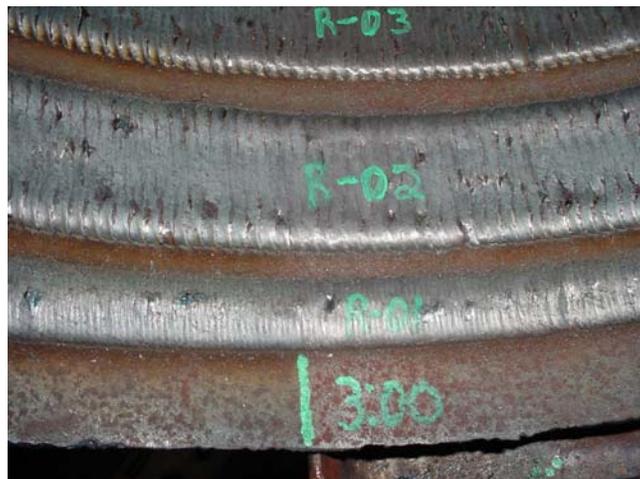
Using the robot welding system, orbital welding parameters using weaving were developed for several bead widths (Figure 11). The pipe is near room temperature when welding is initiated. In general, most weld starts appeared more convex because of this. The weld bead profile slowly changes as steady-state temperatures are achieved in the pipe wall. The development of welding parameters was based on optimizing the bead shape in the steady-state condition. In practice, a programmable weld controller could be used to increase the welding heat input at the weld start. This would provide better weld bead start quality. As steady-state temperatures are achieved, the start parameters could be transitioned to steady-state parameters to provide uniform bead shape.

**Figure 11 - Typical Bead Shapes in Steady-State Condition**

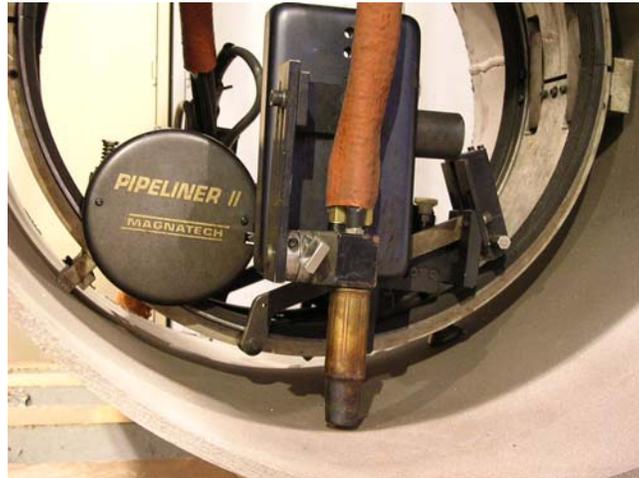
Several years ago, PG&E purchased a welding tractor from Magnatech for internal weld deposition repair procedure development (Figure 12). Since the robot welding system is not portable, the Magnatech system was sent to EWI so it could be used for further parameter development and demonstrations. The Magnatech welding tractor has orbital motion with controls for torch oscillation. The system is limited to a finite number of revolutions that can be made before cables need to be unwound. The controls are analog and do not have high accuracy; however, they are sufficient for preliminary parameter development and demonstration welding.

**Figure 12 - Magnatech ID Welding Tractor Capable of Spiral and Ring Motion with Oscillation**

The Magnatech tractor was interfaced to a Panasonic AE 350 power supply, which provides pulse waveforms and can be operated in a short-circuit mode where artificial intelligence is used to minimize spatter. The current pulsing and short circuiting helps lower heat input and improve deposition rate in out-of-position welds. Pre-programmed current waveforms are provided by algorithms for steel electrodes and many other materials.
